Derailment of wagons in Poland:

**important case for
future cooperation**

Place of derailment: "Sędziszów – Kępie" section

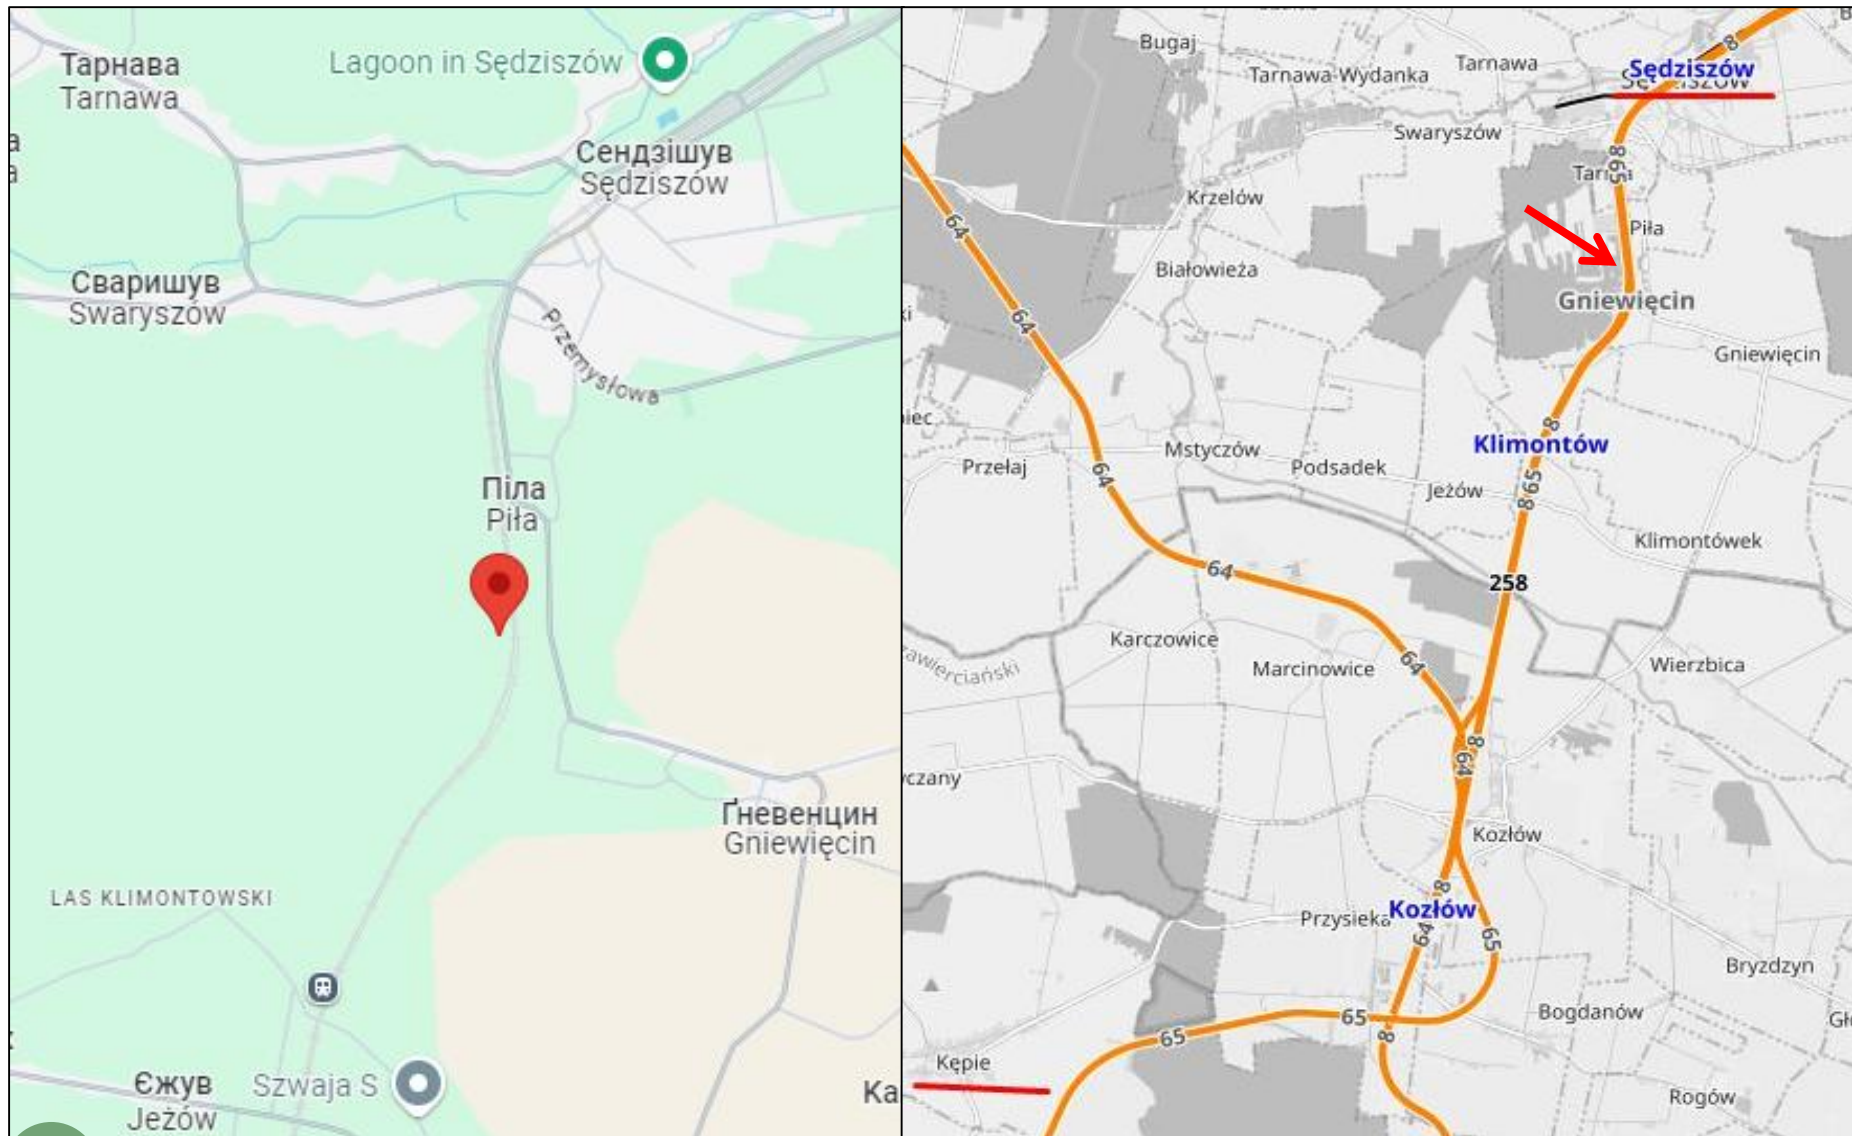
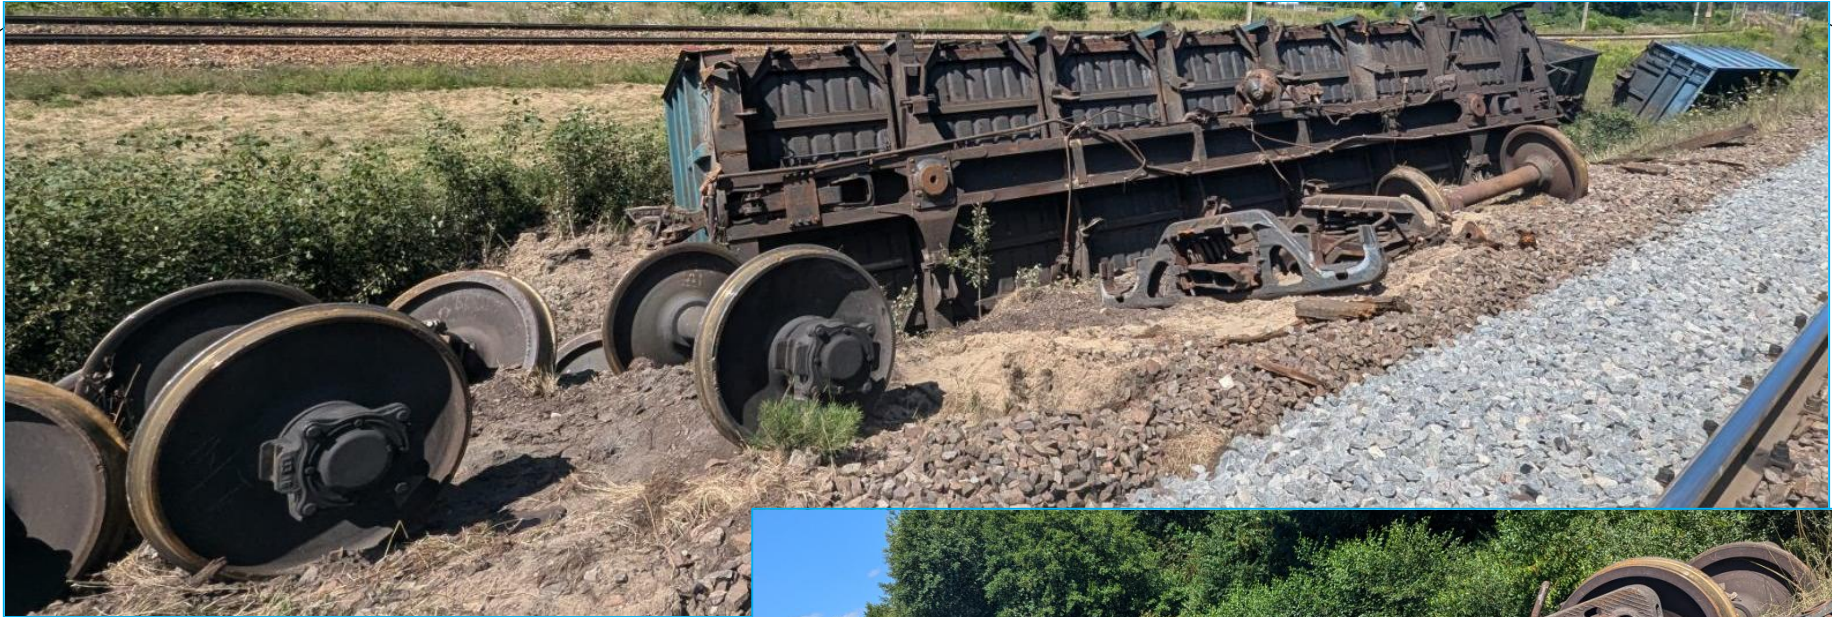
- On July 21, 2024, an incident occurred on the 321st km of the Sędziszów – Kępie section in Poland, resulting in the derailment of 6 empty gondola cars, including one owned by EU-Trans LLC.
- The incident was classified as a category B-II accident and occurred on July 21, 2024 at 18:57 on the Sędziszów LHS – Kępie LHS section, line No. 65 (Bridge over the Bug River – Sławków Południowy), operated by PKP Linia Hutnicza Szerokotorowa Sp. z o. in Zamość.
- This event was a serious test for our company, and also revealed a number of issues that require attention from both Polish Railways and Ukrzaliznytsia.

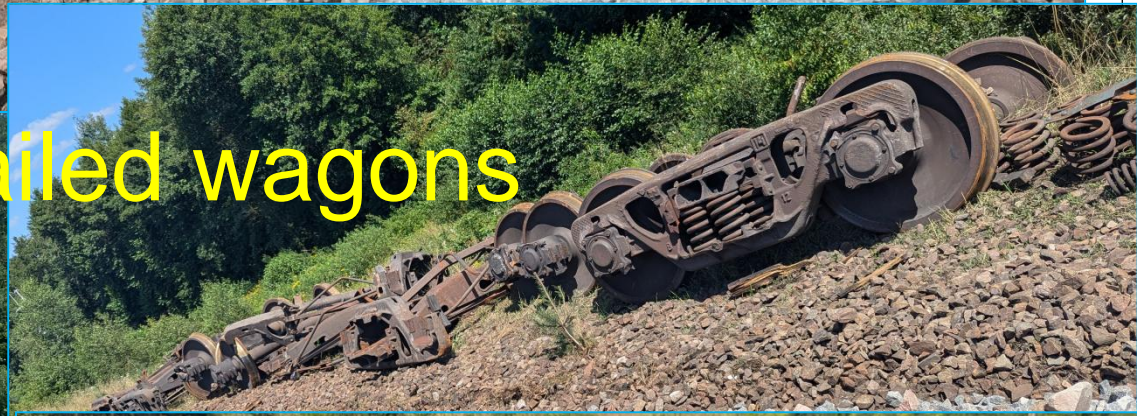
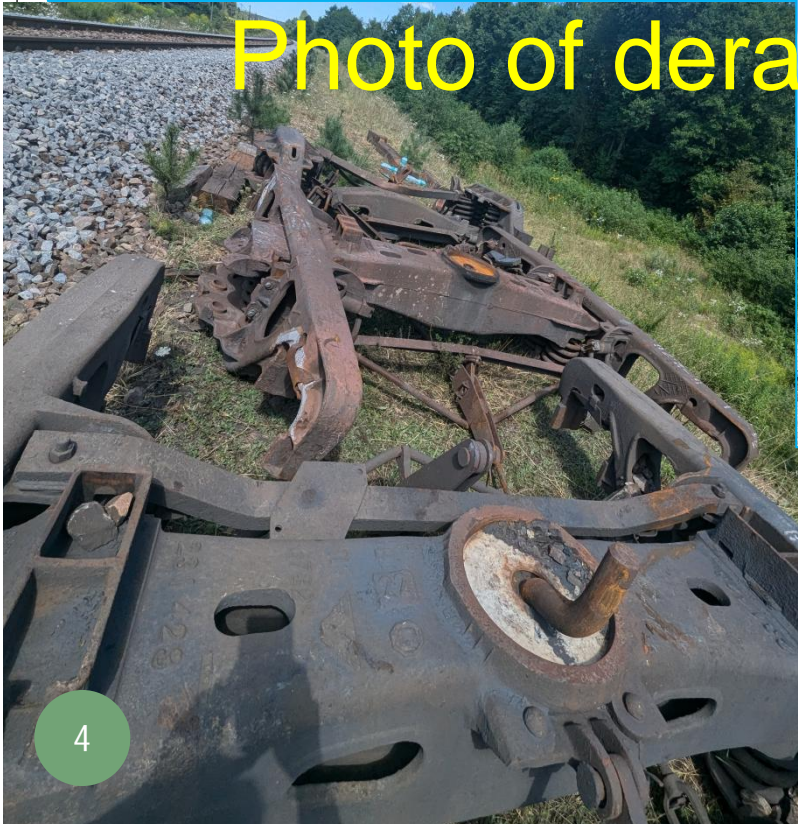
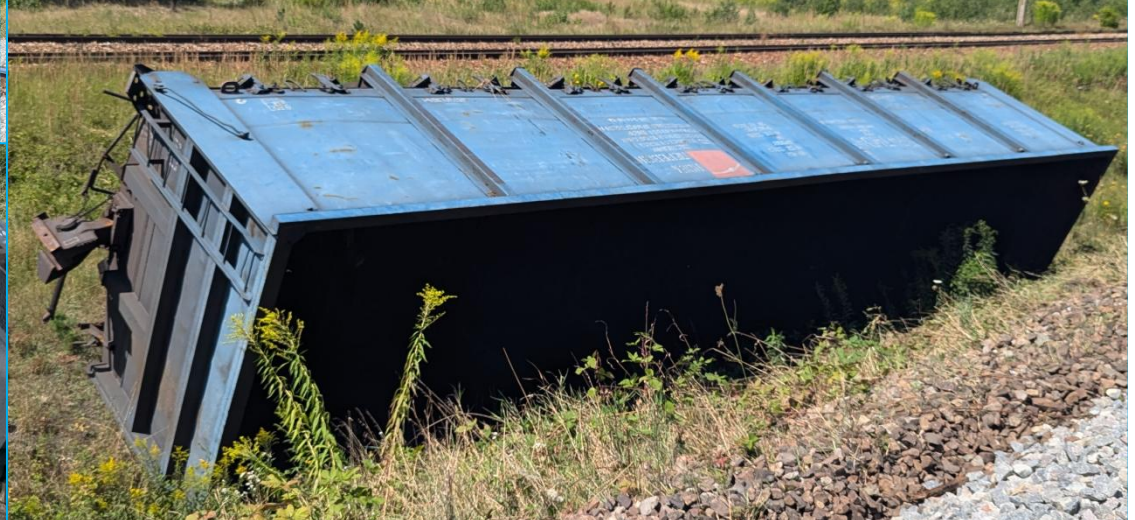
Photo of derailed wagons

- Preliminary assessments show that it was a hit against a concrete block, which caused the train to further break and derail. The culprit wagon was moving behind the train for almost the entire braking distance, leaning only on the front wheelsets. The remaining wagons were scattered on both sides of the track: two wagons on the left, three on the right. The wagon of LLC "EU-Trans" was lying on its side, without brakes and wheelsets, like the other damaged wagons.

- During the inspection of the scene, two super-spring beams and one side frame were found missing from the wagon "EU-Trans", which were then found only later.

- Initial assessments show that the wagons are beyond repair, since they overturned during a transport incident, which could have damaged the backbone beam. According to eyewitnesses, it will be very difficult to lift the wagons due to the lack of space for installing a crane.

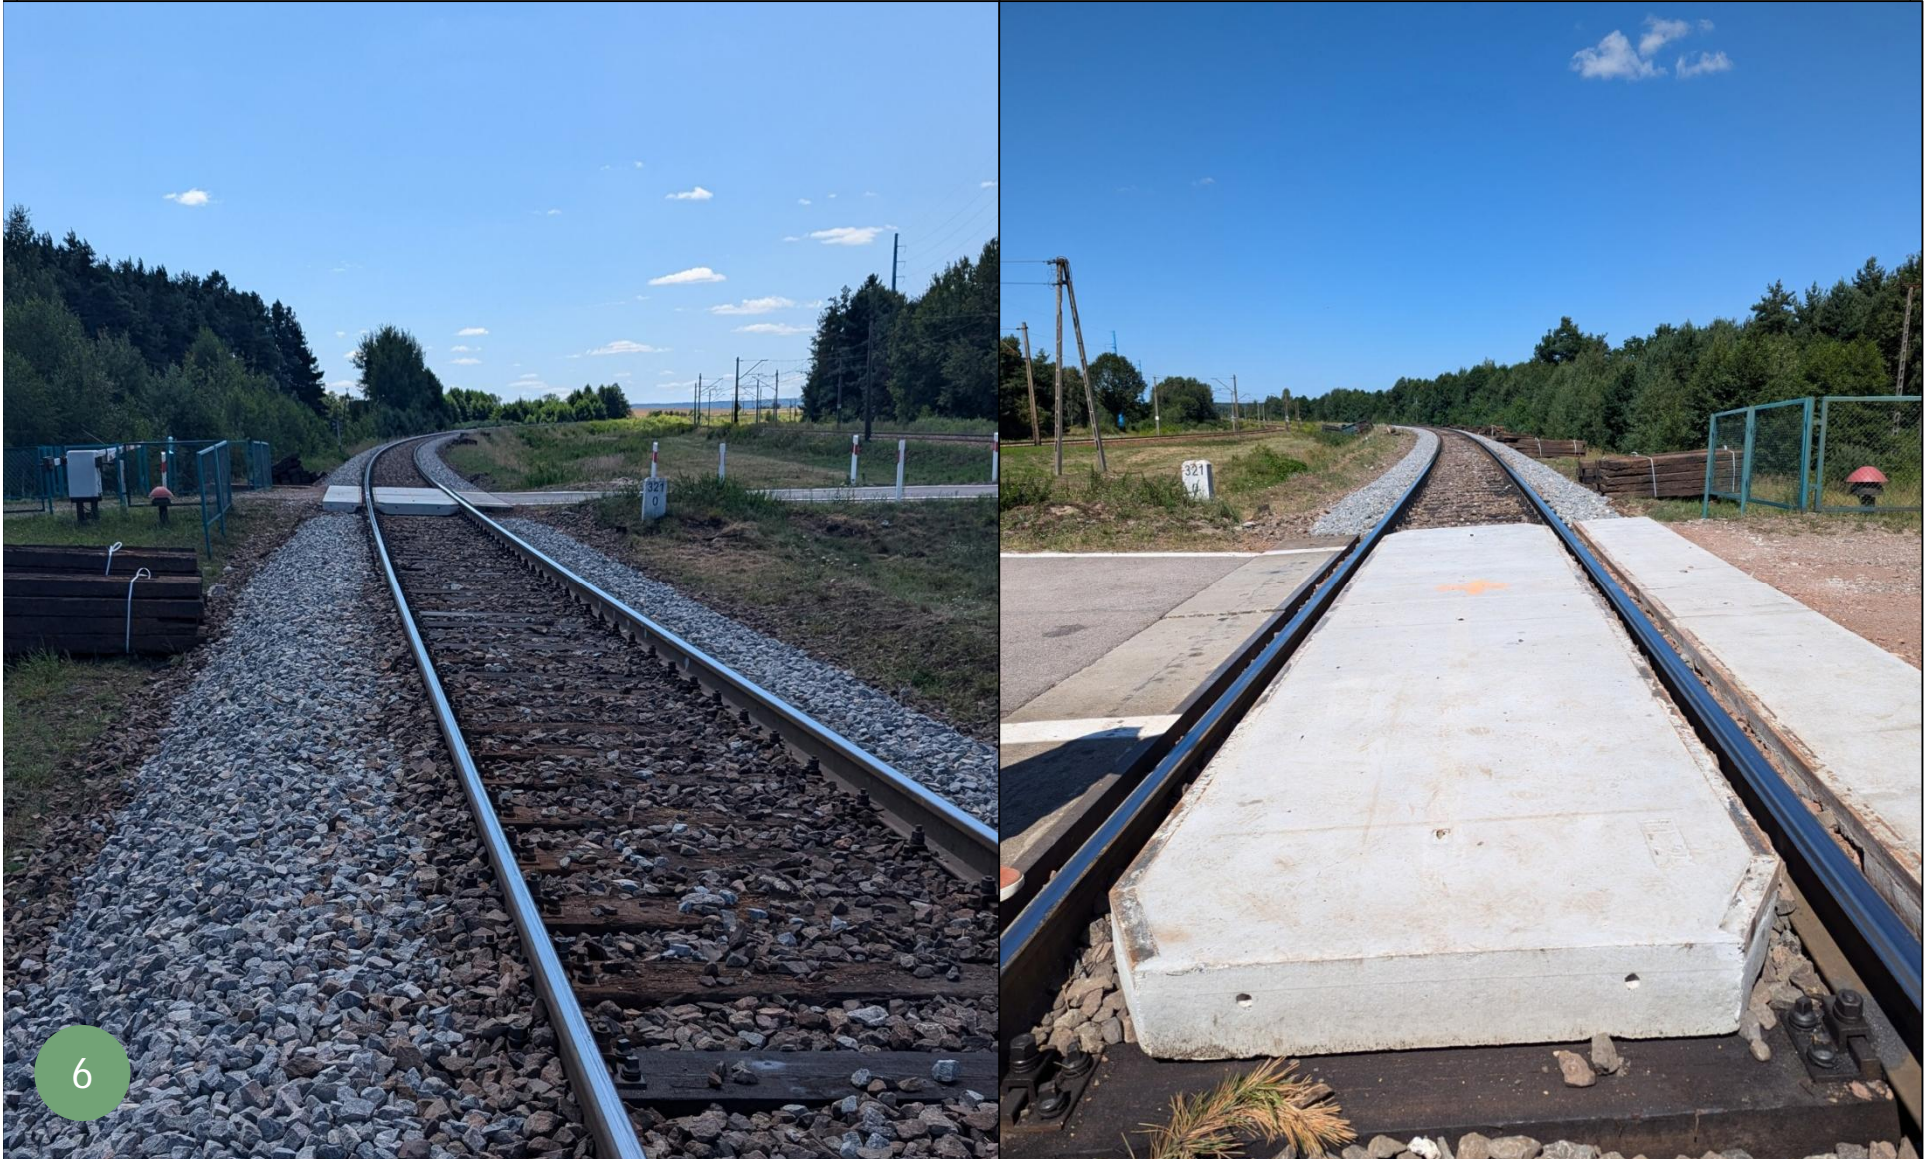
- Before the railway crossing, made on wooden sleepers, traces of damage were noticed, indicating that part of the wagon was dragged along the track. As a result of the initial inspection of the wheelset of the wagon that was the culprit of the incident, traces of an impact with a concrete crossing were found. It is quite likely that this collision caused the wagon to derail. The concrete block was torn off and thrown to the side of the road, and the wheelset was off the track. At the time of the inspection by the railway commission, the accident site had already been repaired, and train traffic was operating normally.

The immediate location of the derailment
is a railroad crossing

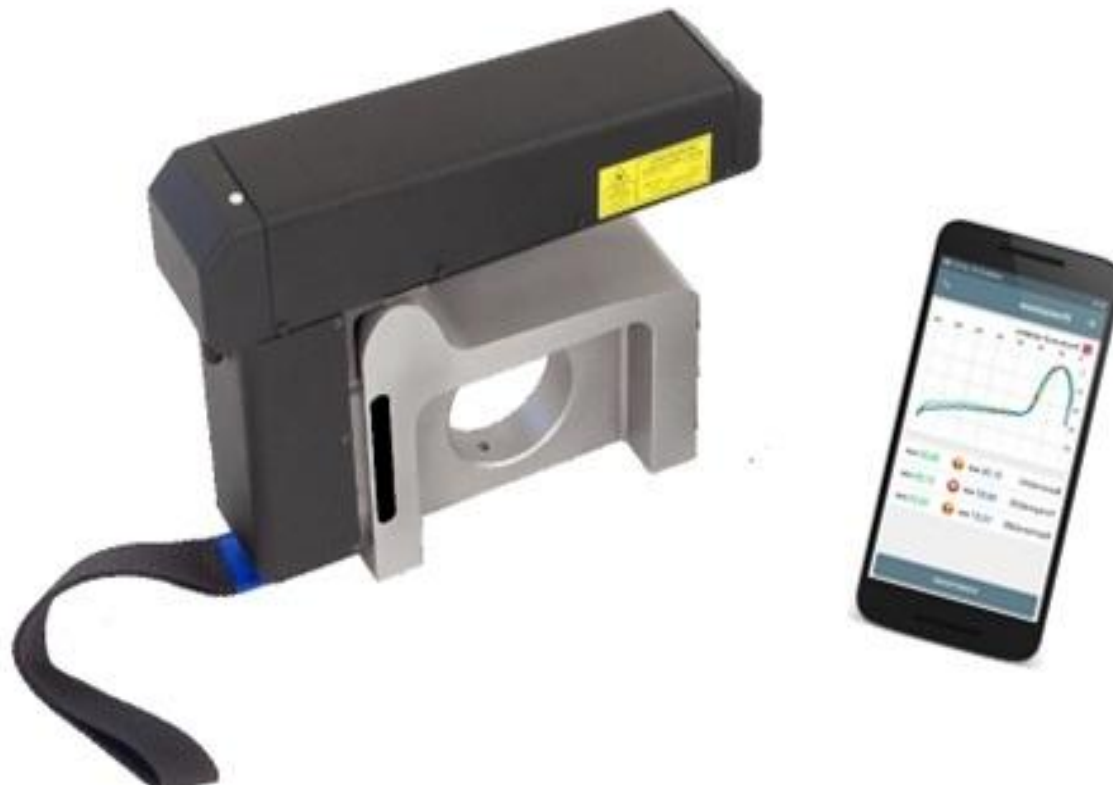
Laser profilometer

- In addition, it was found that in Poland a **laser profilometer** was used to measure the wheelsets, which allows for quick and accurate (**with an accuracy of up to 0.01 mm**) recording of measurement parameters without the need to remove the wheelsets from the wagon. However, this device **differs from the one used in Ukraine, namely, a special template described in the PGV Agreement**, and the accuracy of measurements of which is significantly lower. This leads to discrepancies in the measurement results.

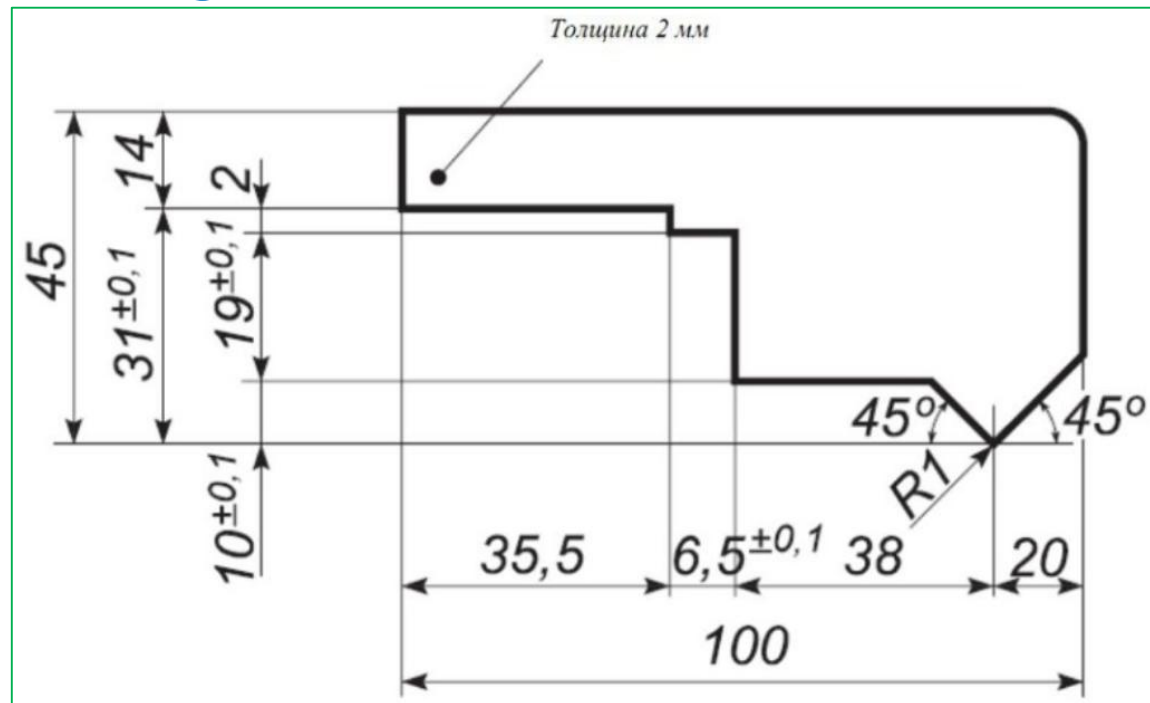
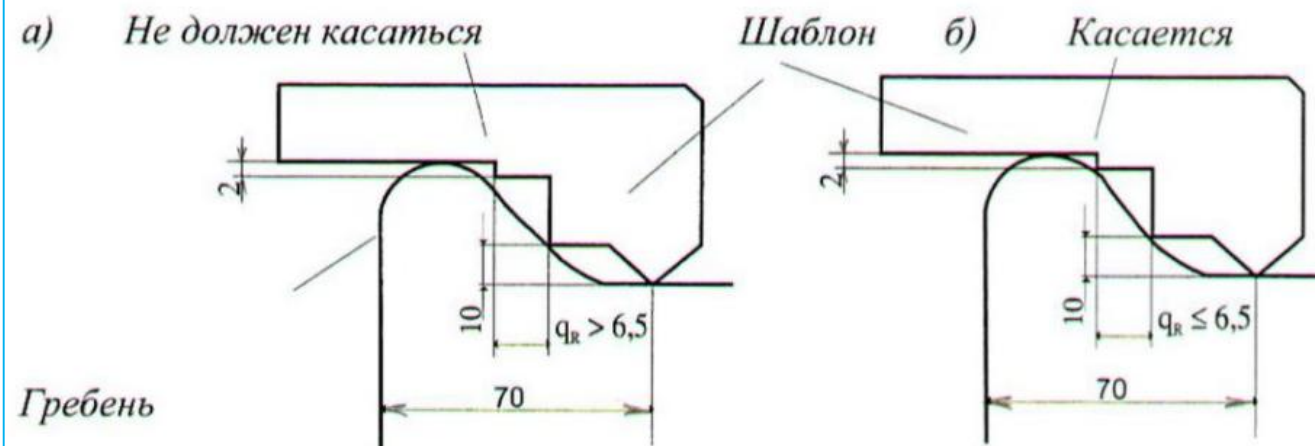
Рис.3

- According to the investigation materials provided by the Polish Railway Commission, **the main cause of the incident was the exceeding of technical parameters** (Qr – crest steepness and Og – crest thickness) on 4 of the 6 wagons, i.e. their non-compliance with the established standards. During the investigation, the need for more thorough inspection of the wagons at the stages of transfer between Ukraine and Poland was revealed. The Commission also drew attention to shortcomings in the process of information exchange between the parties.

Гребни допускаемый (а) и недопускаемый (б)
