Derailment of wagons in Poland:

**important case for
future cooperation**

Place of derailment: "Sędziszów – Kępie" section

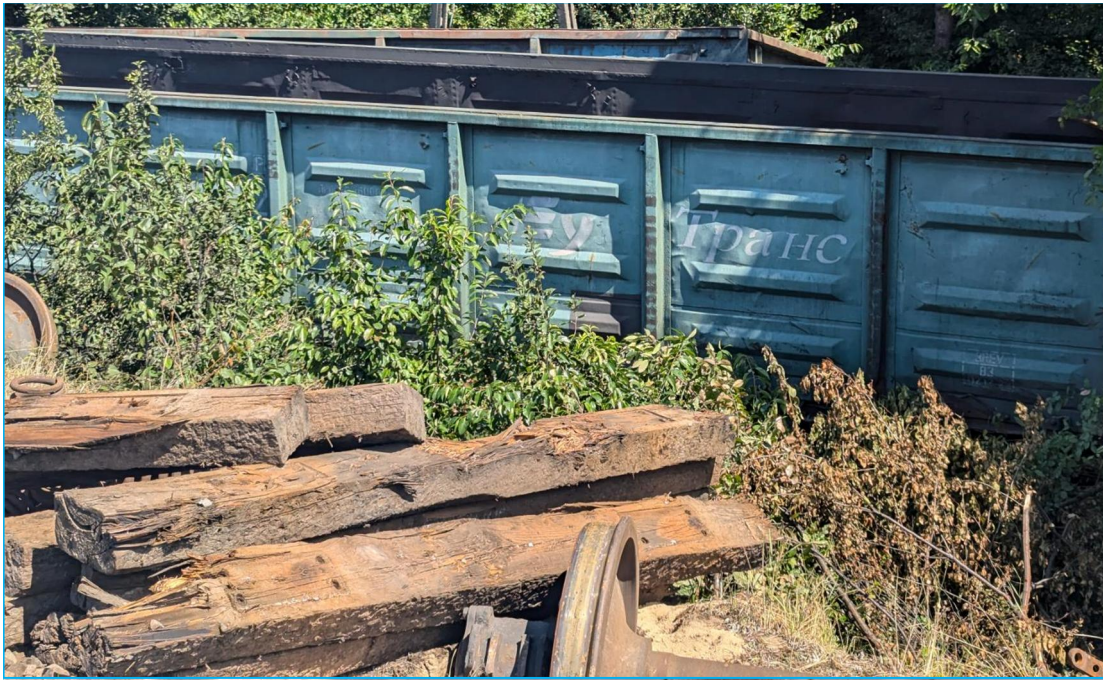
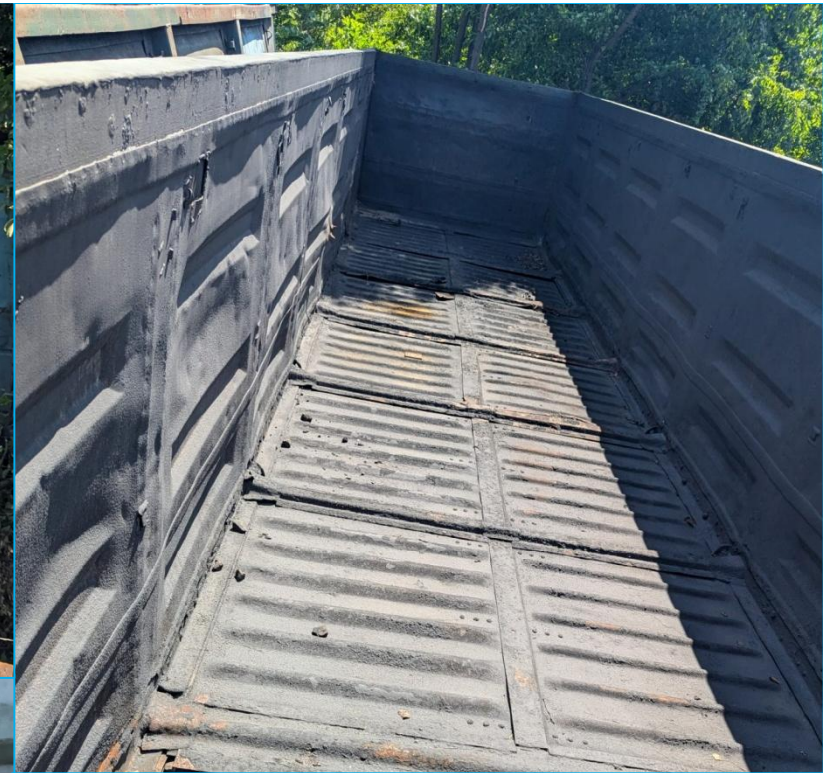
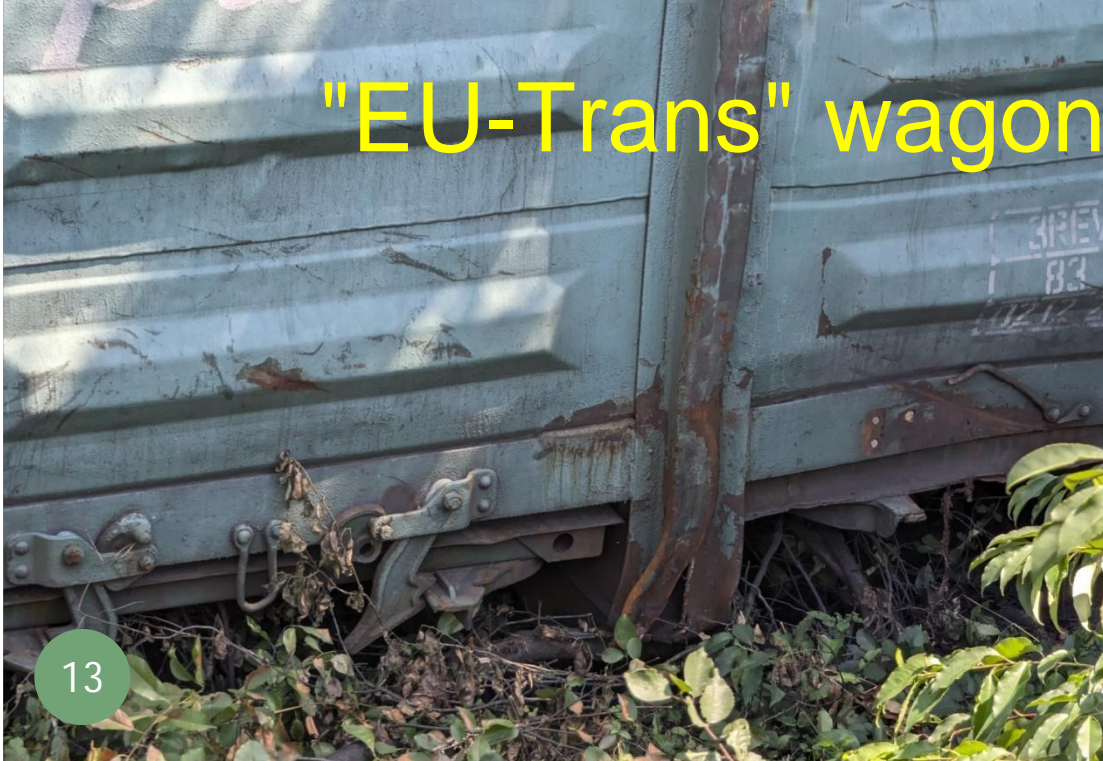
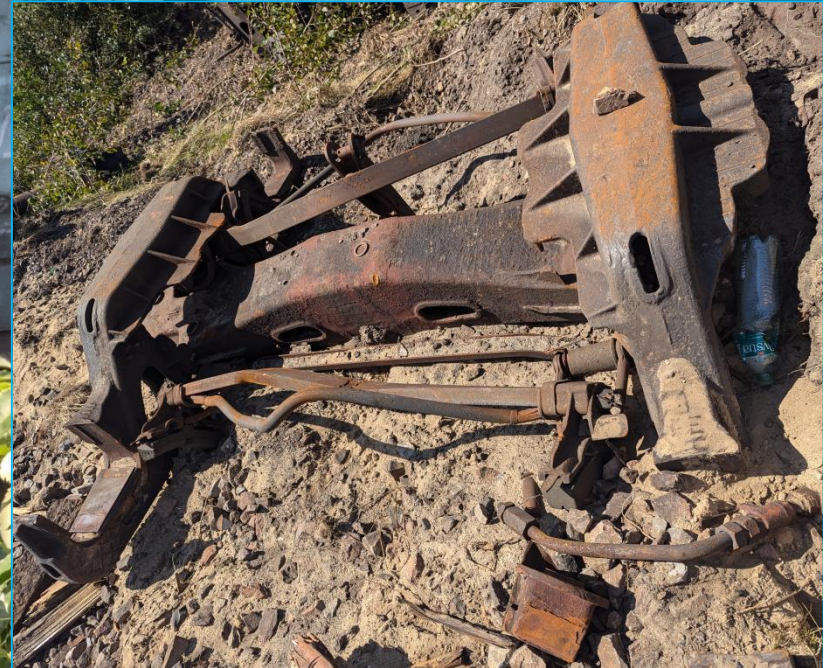
- For the company "EU-Trans" this incident caused significant material losses, and also created difficulties in organizing transportation, despite the fact that there are no claims to our wagon. We see that such cases undermine trust between the parties and require clearer coordination of actions. It is especially important to take into account the specifics of wagons registered in other countries and adapt the procedures for checking and accepting rolling stock.
