# EUROPEAN VISUAL INSPECTION CATALOGUE (EVIC) FOR FREIGHT WAGON AXLES

**to be applied in light maintenance of freight wagons in workshops**

*Joint Sector Group for ERA Task Force on wagon/axle maintenance*

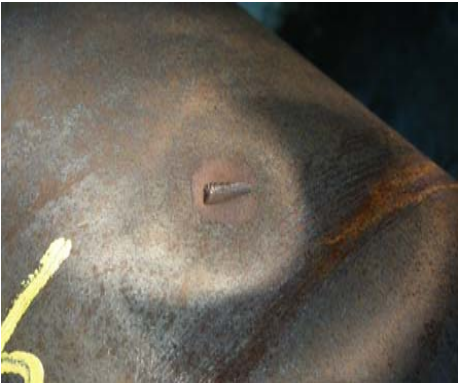
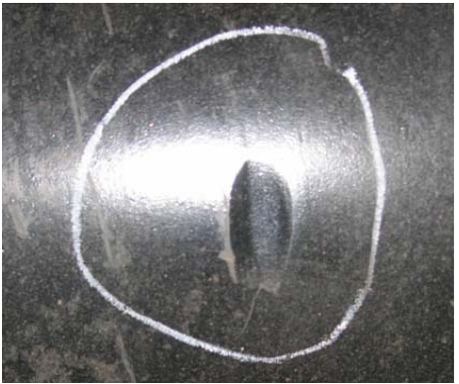
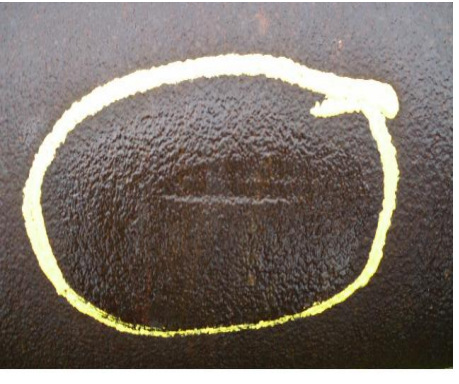
| <b>33 Mechanical damage – sharp edged notching</b> | | <b>Painted axles</b> |

| | Sharp edged notches occur locally and are characterised by sharp-edged transitions. | |
| | Mechanical damage to the base material in the form of notching is inadmissible. | |
| | Remove from service (according to GCU criteria) | Case A |

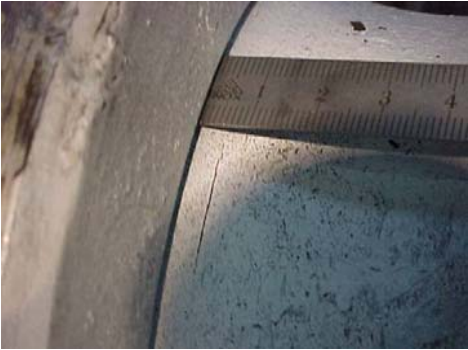
| <b>34 Mechanical damage – cracks</b> | | <b>Painted axles</b> |

| | Cracks occur locally on the shaft material (not on the painting) and are characterised and visible by fine lines. | |
| | Mechanical damage to the base material in the form of cracks is inadmissible. | |
| | Remove from service | Case A |

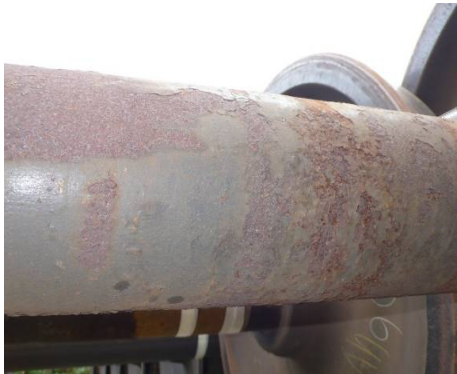
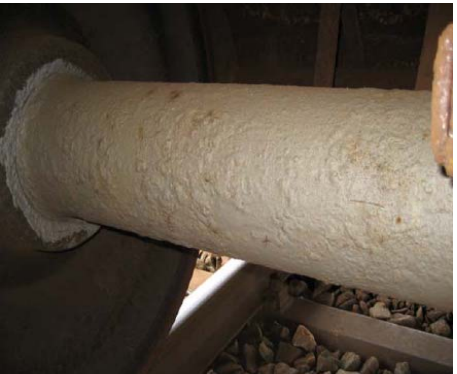
| <b>35 Surface damage – large and heavily corroded areas</b> | | <b>Painted axles</b> |

| | Surface damage to base material in form of large and heavily corroded areas (old corrosion protection) is inadmissible. | |
| | Remove from service | <b>Case B</b> |

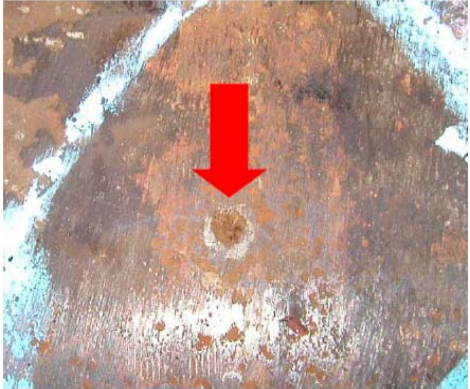
| <b>36 Surface damage – single, deeply pitted corrosion scars</b> | | <b>Painted axles</b> |

| | Surface damage to the base material in the form of marked, local corrosion scars (resulting e.g. from chemical effects) is inadmissible. | |
| | Remove from service | Case B |

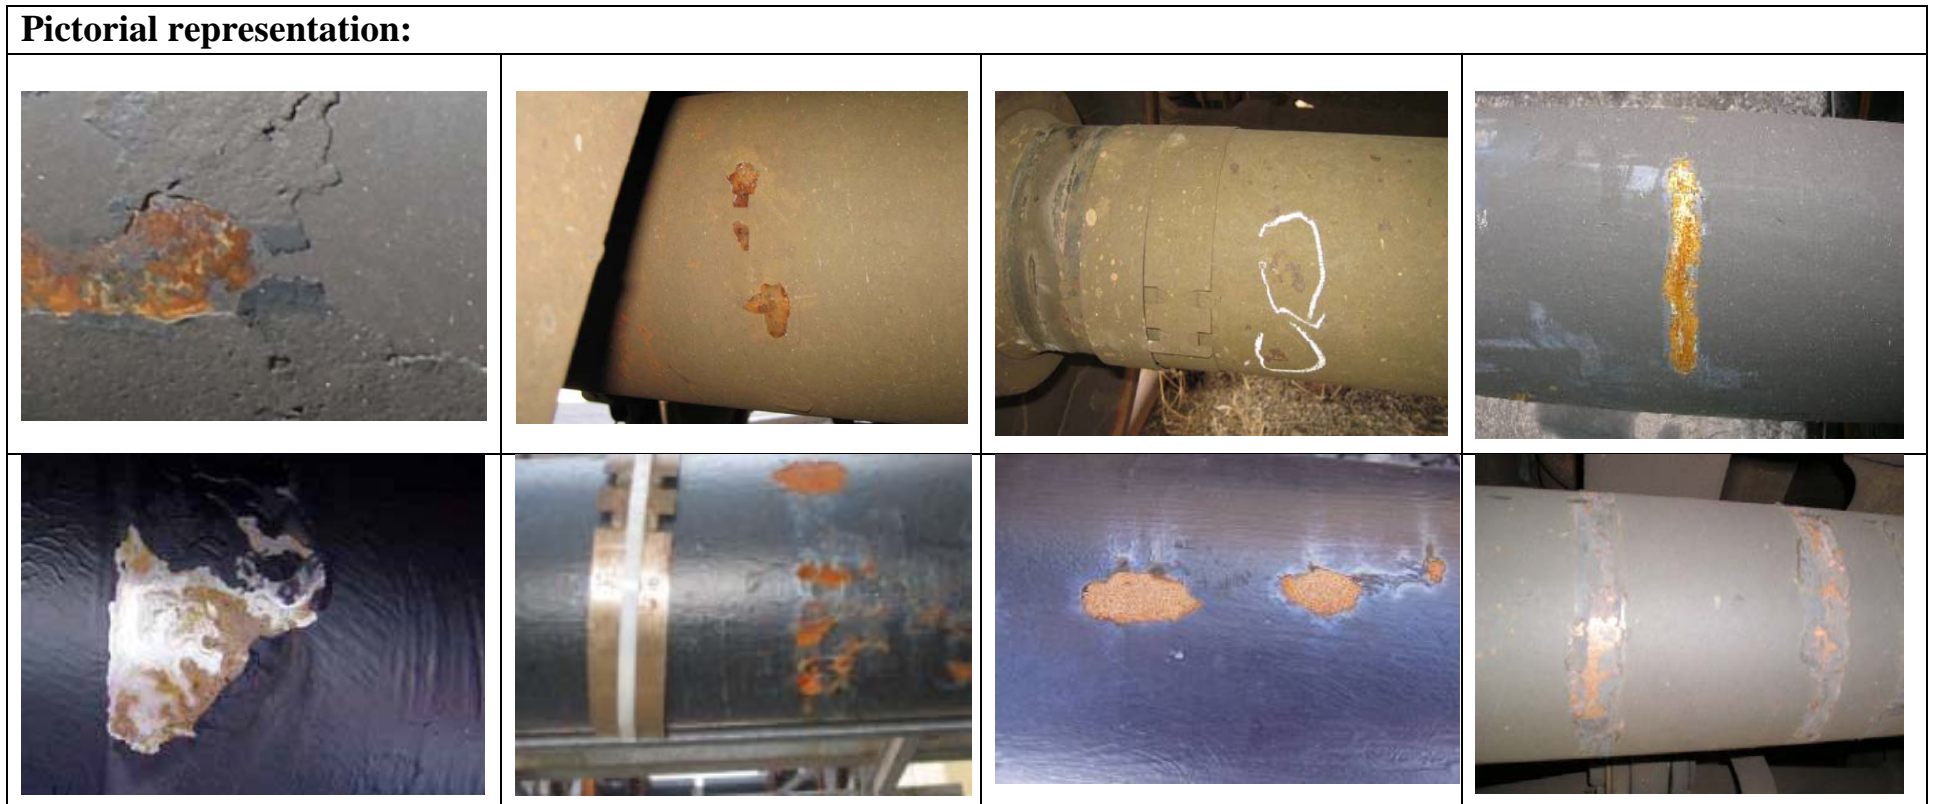
| <b>37 Coating damage – with or without corrosion</b> | | <b>Painted axles</b> |

| | Minor lack of an anti-corrosion coating, whether corrosion is involved or not. | |
| | Leave in service acc. case C and/or repair the damage in situ on the wheelset | Case C |

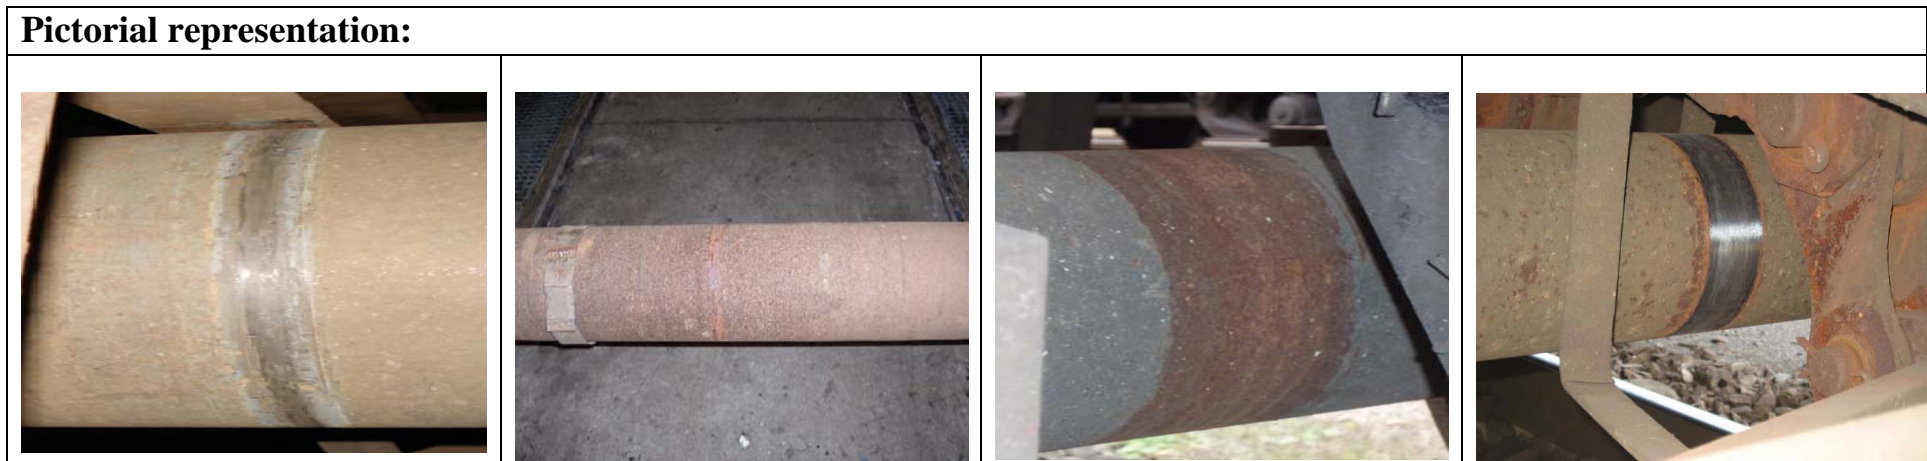
| <b>42 Mechanical damage – smooth edged circumferential grooves</b> | | <b>Unpainted axles</b> |

| | Characterised by smooth transitions in the edges (GCU Annex 9, 1.6.2). Pitting that arises during operation (caused e.g. by brake lever connectors dragging) involves damaged anti-corrosion coating | |
| | if there is damage to the base material > 1mm: (acc. GCU) | <b>Case A</b> |

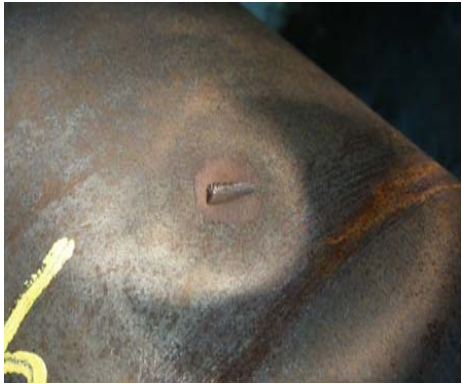
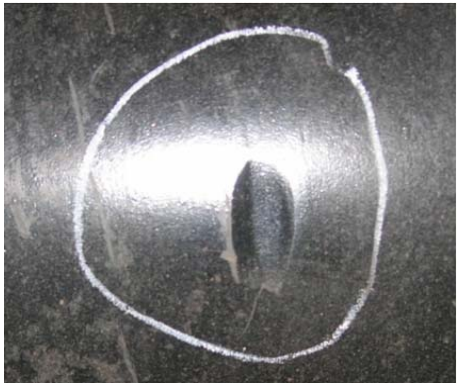
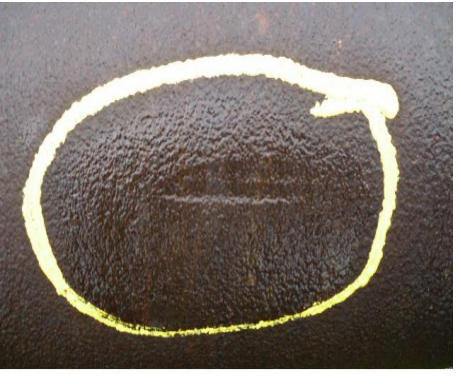
| <b>43 Mechanical damage – sharp edged notching</b> | | <b>Unpainted axles</b> |

| | Mechanical damage to the base material in the form of notching is inadmissible. | |

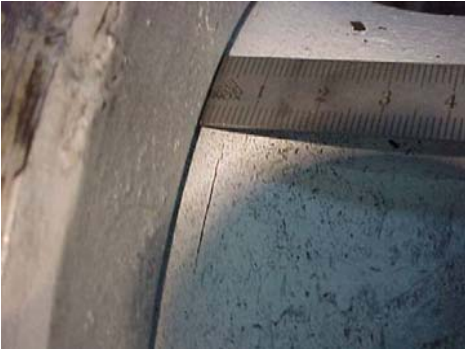
| <b>44 Mechanical damage – cracks</b> | | <b>Unpainted axles</b> |

| | Cracks occur locally and are characterised and visible by fine lines. | |
| | Mechanical damage to the base material in the form of cracks is inadmissible. | |

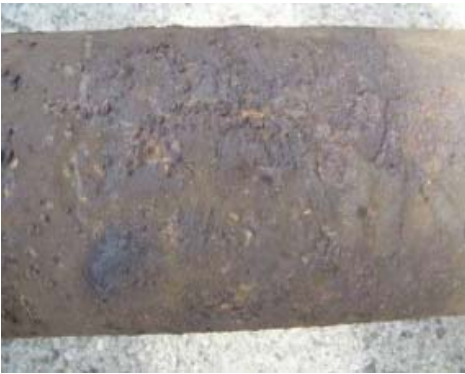
| <b>45 Surface damage – large and heavily corroded areas</b> | | <b>Unpainted axles</b> |

| | Surface damage to base material in form of large and heavily corroded areas (old corrosion protection) is inadmissible. | |
